# Panagiotissa through the layers of time: The Archive's memory of repairs and the present condition of the structure (1691-todate)

Beyza Hilal Altunışık<sup>a</sup>, Mine Esmer<sup>b,\*</sup><sup>a</sup> Restoration and Conservation Program, Fatih Sultan Mehmet Vakıf University, Istanbul 34015, Türkiye<sup>b</sup> Faculty of Art, Design and Architecture, Fatih Sultan Mehmet Vakıf University, Istanbul 34015, Türkiye

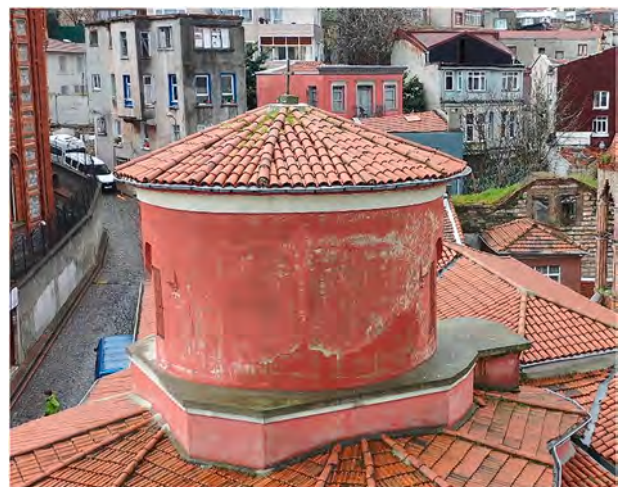
The analytical surveys and detailed on-site observations conducted within the scope of this study have revealed a range of significant deterioration issues affecting the structure, many of which require urgent and carefully planned intervention (Figs. 24–25) (Table 3).

**Fig. 24** Moisture problem in the main dome (Altunışık, 2024).

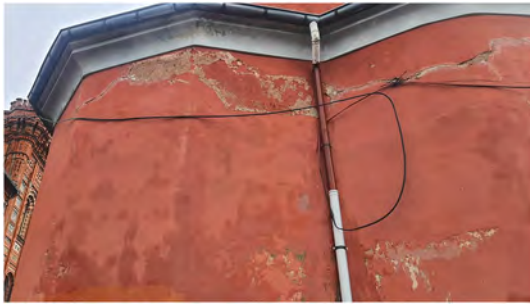
**Fig. 25** Moisture problem on the east façade of Muhliotissa (Altunışık, 2024).

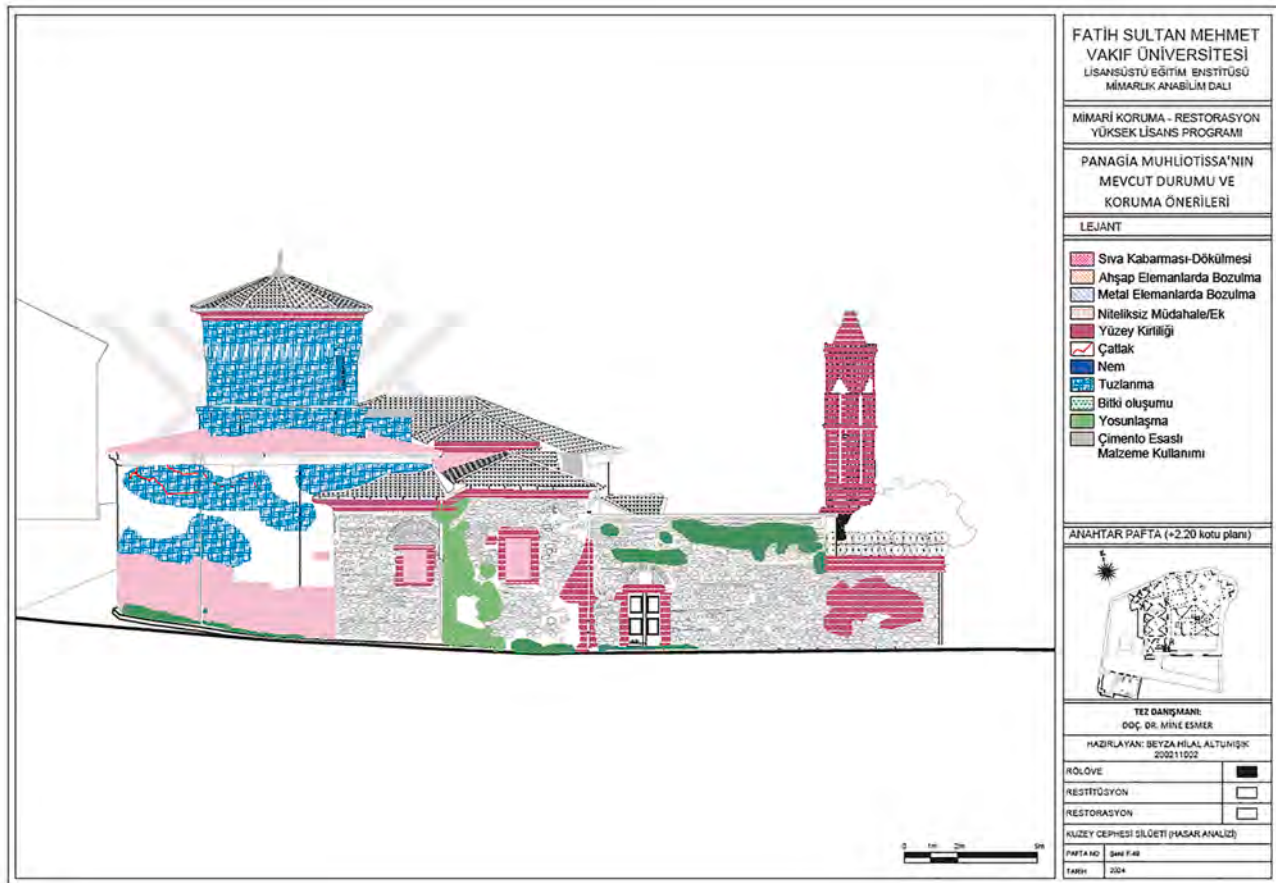
| Problem category | Identified damages and deteriorations |
|---|---|
| <b>Poor-quality interventions</b> | <ul style="list-style-type: none"> <li>• Surface erosion on window jambs.</li> <li>• Use of Marseille-type tiles instead of original Turkish-style tiles on the roof.</li> <li>• Onduline covering on the terrace floor for waterproofing.</li> <li>• Cement residues on roof ridges.</li> <li>• Use of spaces like the gallery floor as storage, incompatible with the church’s function.</li> </ul> |

Fig. 26 Muhliotissa, current survey, north silhouette, damage analysis (Altunışık, 2024).

During the conservation and repair phase, priority should be given to the removal of later additions that compromise the building's authenticity. Interventions such as cement-based mortars on the roof, partial onduline coverings, exposed cables, and antennas should be eliminated. The roof covering should be renewed using traditional Turkish-style tiles compatible with the original character of the structure, accompanied by the implementation of effective waterproofing measures. To mitigate the effects of ground moisture, a drainage system should be installed around the building perimeter. Fragile frescoes at risk of detachment should be consolidated by qualified conservators, followed by careful surface cleaning and, where necessary, minimal and reversible retouching carried out in accordance with scientific conservation standards (Fig. 27). Additionally, deteriorated wooden seating elements and sheet metal-clad doors should be repaired, while existing metal tie rods should undergo appropriate conservation treatment to prevent corrosion.
