Characterization of stone materials from the Roman Caracalla Bath in Ancyra

Abstract: The Roman Caracalla Bath was built during the reign of Roman Emperor Caracalla (circa AD 200). Today it exists only in the form of wall remnants at the foundation level and functions as an open-air museum. It is located on a mound approximately 2.5-m high along Ulus's Çankırı Street in Ankara. This research paper aims to identify the characterization and implications for provenance of the stone materials used in the construction of the bath by using mineralogical, petrographic, and geochemical definitions. The results obtained from the stone materials also provide guidance for restoration and reinforcement of the bath. In this study, the 13 stone and 2 stone tessera materials were examined using petrographic analysis to determine their provenance, along with X-ray fluorescence analysis to identify their chemical composition. The mineralogical composition of each stone shows that the samples can be classified into five subgroups: andesite, limestone, marble, sandstone, and tuff. The andesite was related to Hüseyingazi-Kale and the limestone to the Haymana region, the marble was from Afyon-İscehisa

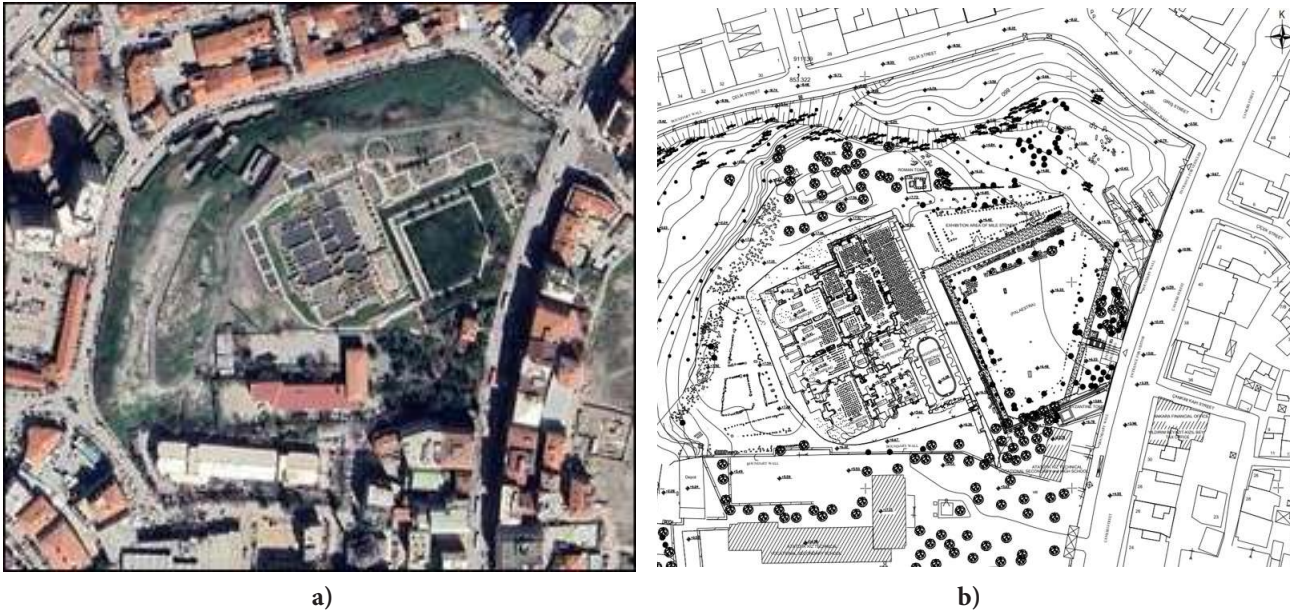
Figure 2. (a) The Google Earth photograph of the Roman (Caracalla) Bath (Google Maps, 2024), (b) The site plan drawing of the Roman (Caracalla) Bath⁷, 2024 (updated from Tanrıverdi, 2018).

entrance to the remains, used as an open-air museum, is accessed by stairs from Çankırı Street on the eastern side of the site. Vehicular access to Çankırı Street, which connects the Ulus and Kızılay centers of Ankara and experiences medium traffic density, is provided by a secondary entrance for service vehicles at the northeast corner. To the south of the area there is a high school, to the west commercial units, and to the east car repair shops, hotels, shops, and offices. For security purposes, the entire area is surrounded by stone walls and iron railings 1.10–1.80 m in height, depending on the height difference between the topography and the street (Mutlu, 2012) (Figures 2a and 2b).

The Roman (Caracalla) Bath in Ankara, whose original remains are visible at the foundation level, consists of two parts: the remains of the bath building (blue area on the site plan) and the open area palaestra (red area on the site plan). Based on Akok's studies (1968), who led the excavation, and the on-site examinations, the remains of the bath building include the piscina (P-1) and apodyterium (A-2) in the frigidarium section. These are

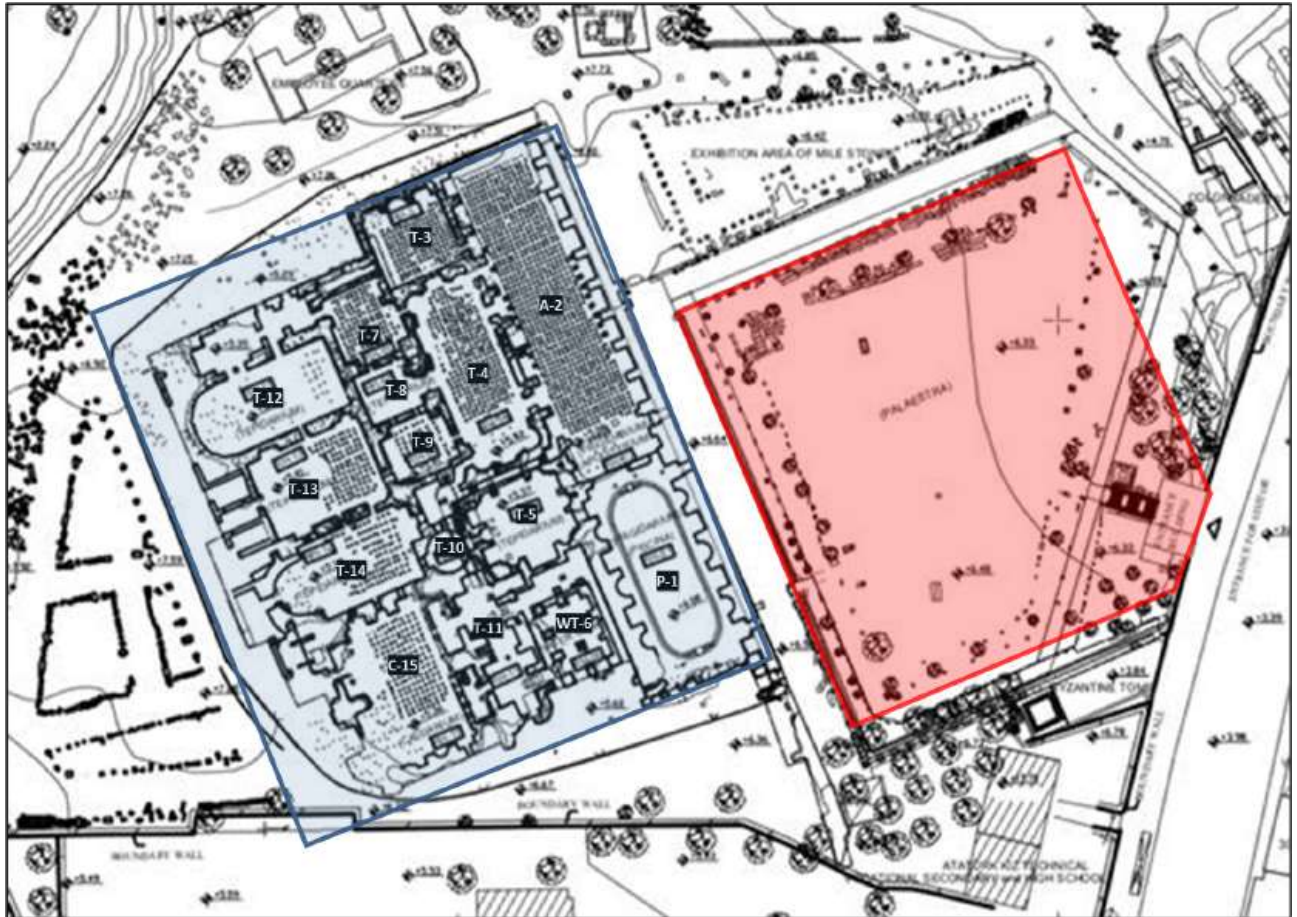
Figure 3. The remains of the bath building (blue area on the site plan) and the palaestra (red area on the site plan), 2024 (updated from Tanriverdi, 2018).

followed by tepidarium sections (from T-3 to T-14), which form a large part of the bath, the caldarium section (C-15) in the southeast corner, and the water tank (WT-06) (Figure 3).

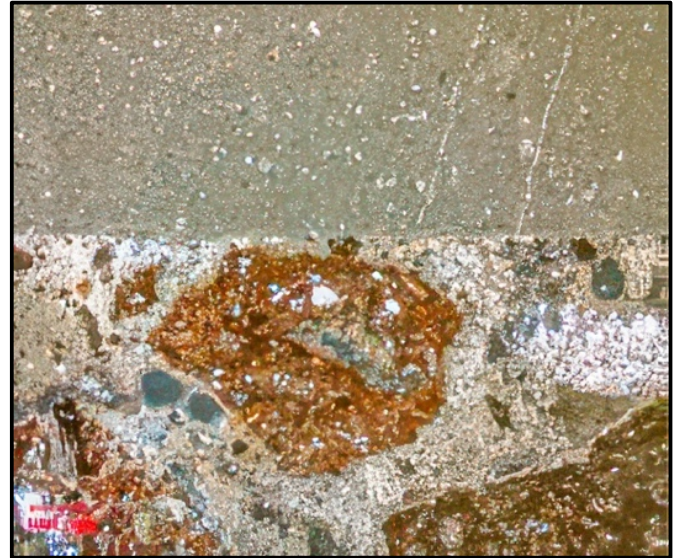
Figure 7. Thin section microphotographs of the stone tessera samples (photos: Kadioğlu, 2024).

Thin section analyses were conducted on the stone tesserae and their mortar layers (tessellatum and setting bed) from the mosaics in the piscina. Although ancient mosaics typically have four layers (rudus, nucleus, setting bed, and tessellatum) (Palomar et al., 2011), not all layers are visible in stone tesserae and mortars of the pool. In the examination, only the nucleus and setting bed layers were clearly distinguished (Figure 7). The results indicate that the tessera samples belong to the rock group of radiolarite and originate from the village of Elmadağ Irmak near Ankara (Table 6; Figure 8).

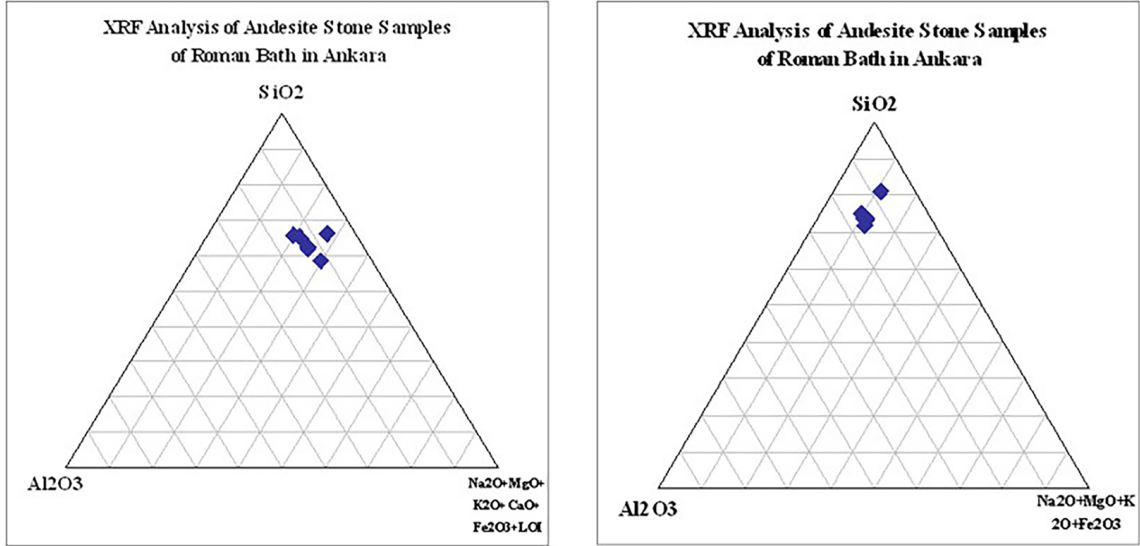
Figure 9. XRF analysis triangle plotting of andesite stones: (a) SiO₂-Al₂O₃-Na₂O+MgO+K₂O+CaO+Fe₂O₃+LOI, (b) SiO₂-Al₂O₃-Na₂O+MgO+K₂O+Fe₂O₃.

The trace elements identified are listed. These results confirm that their chemical compositions are representative of their respective rock groups. Based on the major oxide composition results from the XRF analysis, andesite is categorized into three groups on a triangular plot. Two of these groups indicated largely comparable values, whereas the other group primarily was concentrated on repairing the samples (Figure 9).

The results of the XRF analysis reveal that the stones exhibit distinct chemical characteristics corresponding to their respective rock groups (sedimentary, metamorphic, volcanic, etc.). The triangle plotting schema indicated that the andesite samples could be categorized into three groups. Two of these groups exhibited mostly similar values; the different one was mostly repairing samples.
