n. 33, 2026

# Conservation Challenges of Cultural Heritage: Ottoman Baths in Istanbul's Historic Peninsula

Zeynep Tanrıverdi\*, Emine Selcen  
Cesur\*\*

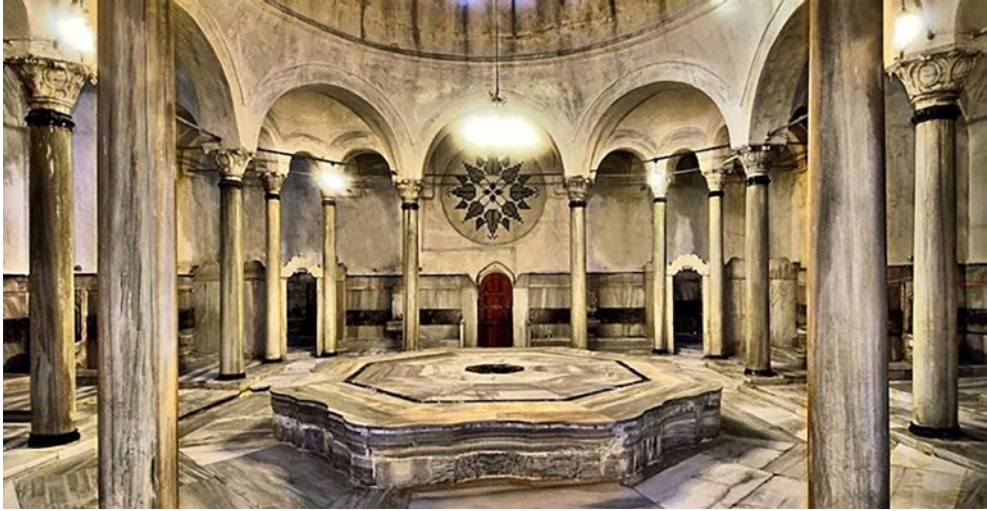
Fig. 1. The view of the *göbek taşı* (central heated marble platform) in the *sıcaklık* (hot room) of the bath (TooIstanbul, 2025)

Ottoman baths were designed with a specific spatial arrangement reflecting the customary social practices associated with bathing. The *soğukluk* (cold room) served primarily as a changing area, typically featuring a *seki* (square or rectangular platform arrangement) along the walls for seating, storage niches for shoes and clothes, and occasionally a fireplace set within wall niches, used to provide moderate warmth and to prepare refreshments such as tea and coffee. This space also functioned as a social area, where visitors could converse or enjoy refreshments<sup>25</sup>. Adjacent to the *soyunmalık*, the *ılıklik* (warm room) provided a transitional environment to gradually acclimate bathers to the heat, incorporating resting platforms along the walls and small areas for shaving and toileting, sometimes arranged in an *aralık* (a transitional/intermediate space) which was later integrated into the main warm room after the 16th century<sup>26</sup>. The *sıcaklık* (hot room) comprised the *iwan* (*eyvan*, a vaulted space open on one side) and *halvet* (private bathing cell), with entrances designed for privacy. Continuous low platforms with *kurnas* (basins) for hot and cold water lined the walls, while the central *göbek taşı* (central heated marble platform) offered a multipurpose surface for resting, sweating, or massage. Floors and lower walls were typically clad in marble, and wastewater from the *sıcaklık* was directed through channels that also served to flush toilets<sup>27</sup>. Adjacent to the hot room, the *külhan* (furnace room) housed the furnace and fuel storage, traditionally wood but sometimes coal or diesel oil, with copper boilers facilitating rapid water heating and arched chimneys ensuring effective airflow<sup>28</sup> (Fig. 1).

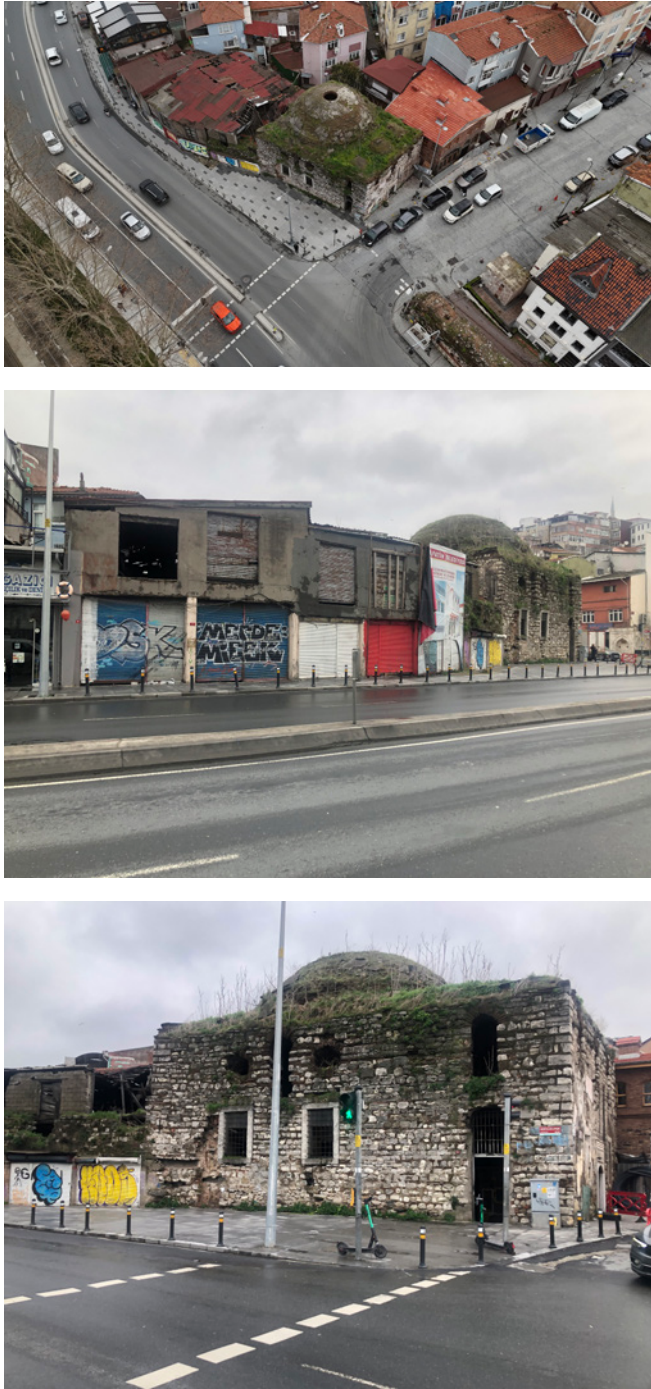
Fig. 3. (a) Aerial photograph; (b-c) coastal road facade of the Ayakapı Bath (Photos: Authors, 2025)

The Cibali Ayakapı Bath faces significant conservation challenges arising from natural hazards, including seismic activity and fire, as well as atmospheric deterioration related to its coastal setting along the Golden Horn. Urban pressures from the adjacent coastal road have introduced vibrations and pollution, contributing to physical degradation. Historical inefficiencies in fuel consumption, combined with economic constraints, have further affected its maintenance. In addition, the building's transfer to private ownership and subsequent inappropriate interventions have compromised its architectural integrity, while declining social relevance has reduced its functional viability. As a result, the Ayakapı Bath is currently at risk of irreversible loss.

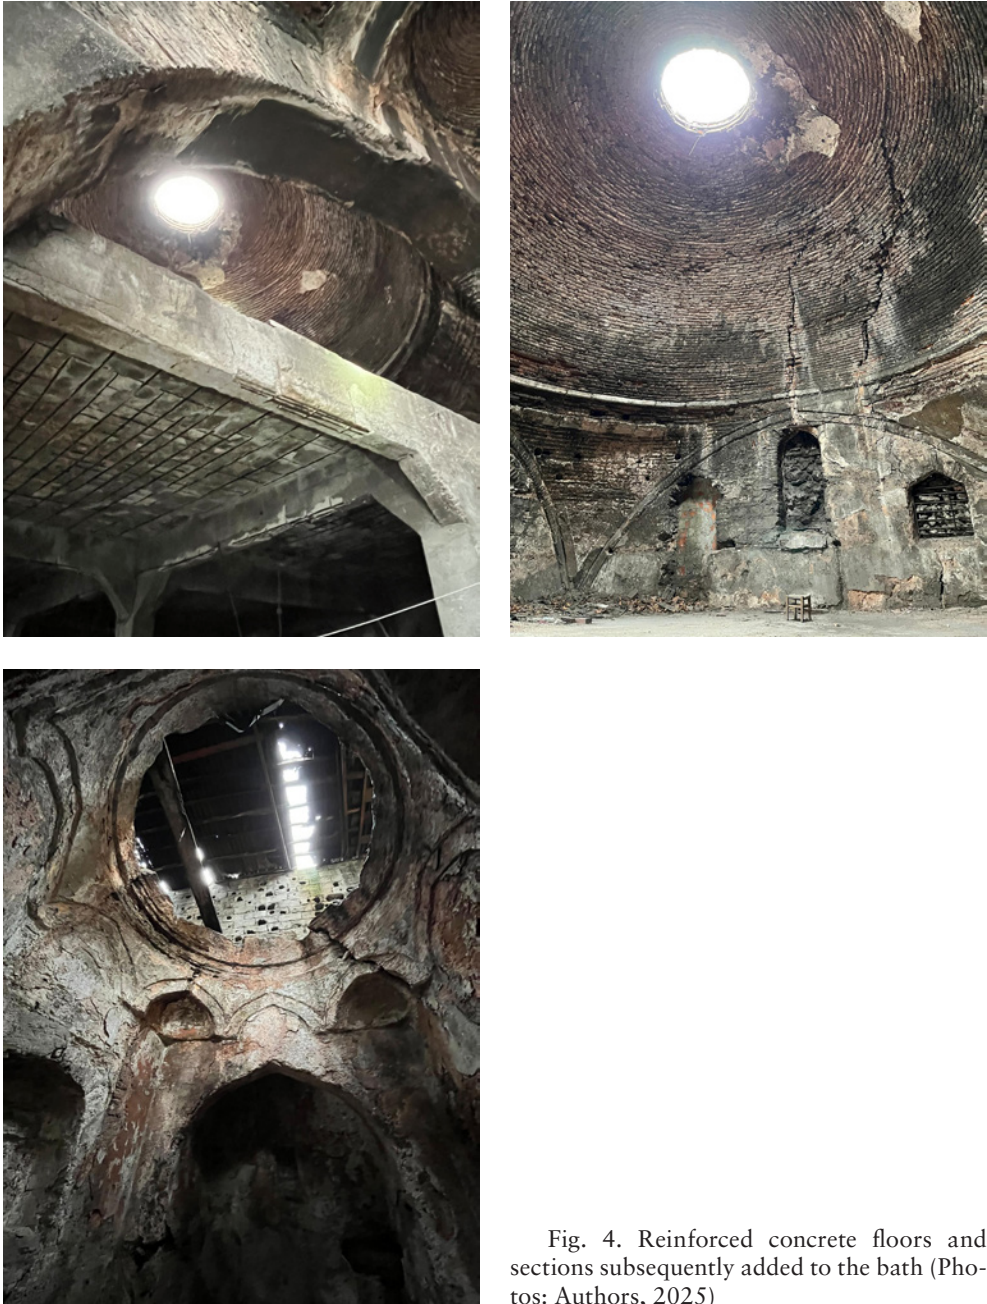
Today, only one corner *halvet* survives, while the domes of the *sıcaklık* and *ılıklik* have collapsed. Unqualified later additions and makeshift shops have encroached upon the site, obscuring its original volume and material authenticity (Fig. 3b). Deterioration stems primarily from human-induced causes – unauthorized alterations, neglect, and inappropriate cement repairs – and is compounded by environmental factors such as sea salt, air pollution, and vibrations from the coastal road. Stone surfaces show erosion, biological growth, and salinization (Fig. 3c). In addition, the reinforced concrete mezzanine, inserted into the interior during the 1940s, is now corroded (Fig. 4).

Fig. 4. Reinforced concrete floors and sections subsequently added to the bath (Photos: Authors, 2025)

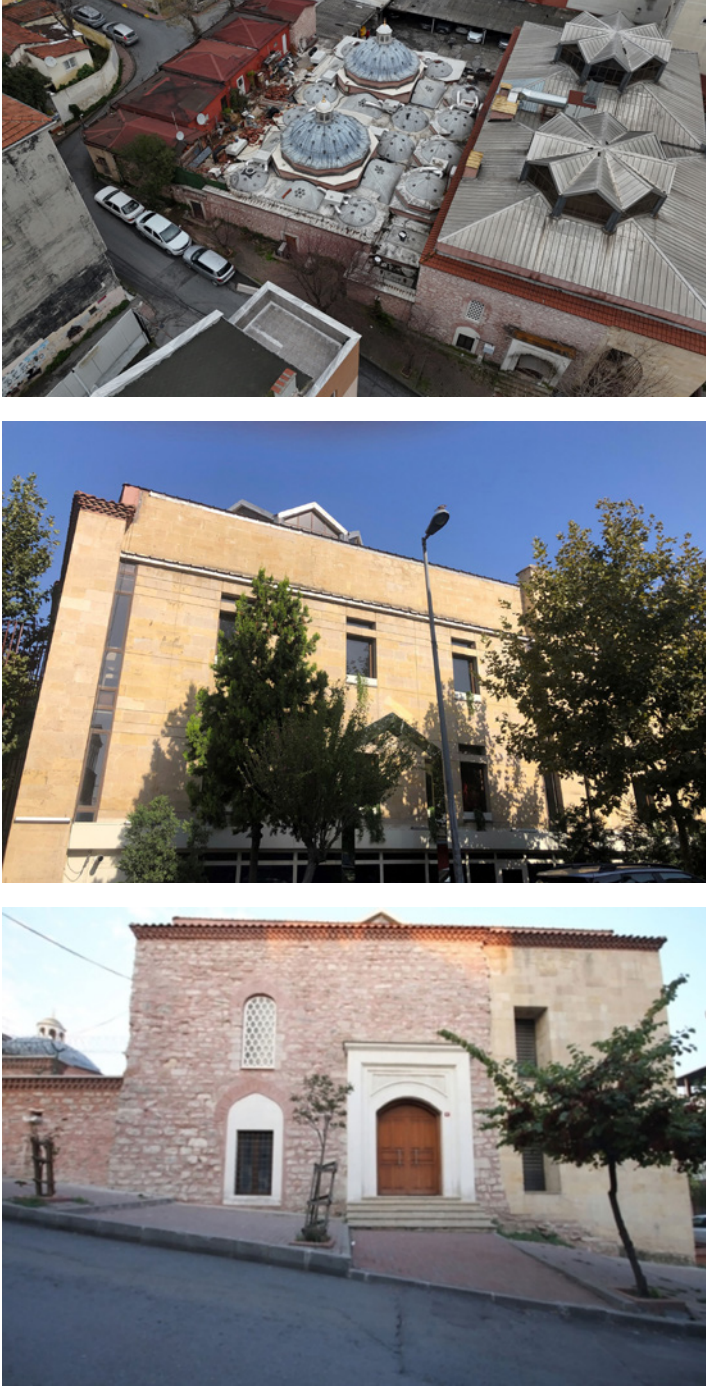
Fig. 5. (a) Aerial photograph; (b-c) view of the modern addition to the Kapıağası Yakup Ağa Bath (Photos: Authors, 2025)

The Kapiğası Yakupağa Bath is similarly affected by environmental hazards and broader socio-economic transformations that have led to a decline in use. Its transfer to private ownership has resulted in inappropriate interventions and functional alterations that undermine its historical character. Urban planning decisions, including the introduction of a road cutting through part of the *soyunmalık* section, have significantly disrupted its spatial organization and architectural coherence. Structural additions, such as a reinforced concrete extension faced with modern stone incompatible with the original alternating stone-and-brick masonry, have further diminished its authenticity. Moreover, successive adaptive reuses as a restaurant, bazaar, exhibition space, and retail units have fragmented the original functional unity and distorted the spatial narrative of the building.

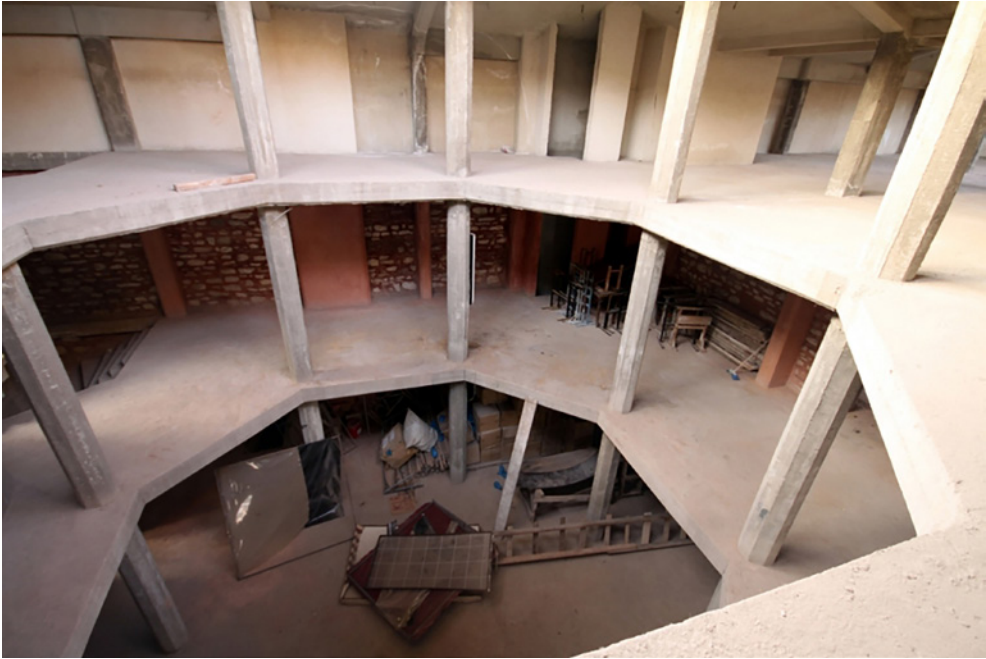
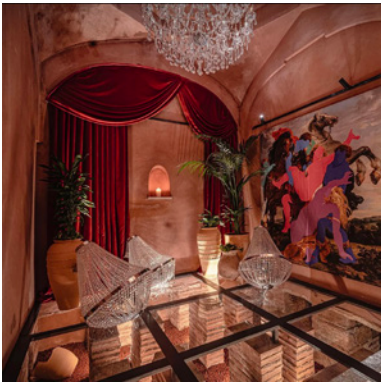
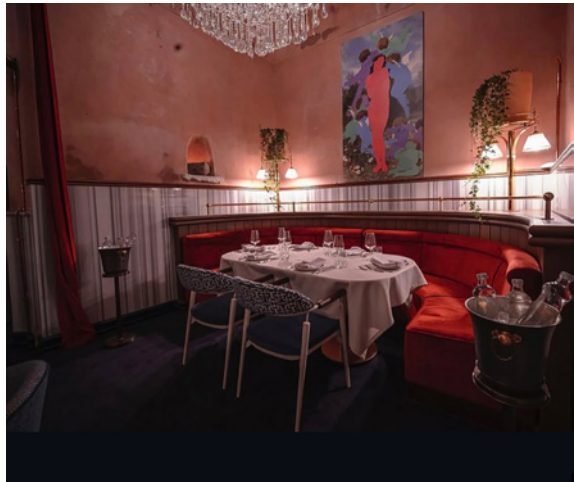
Fig. 6. (a) Addition of reinforced concrete mezzanine floors to the *soyunmalık* (cold room) (Ağa Hamam, 2012); (b-c) interior view of the bath spaces refunctoned as a restaurant (Photos: Authors, 2025)

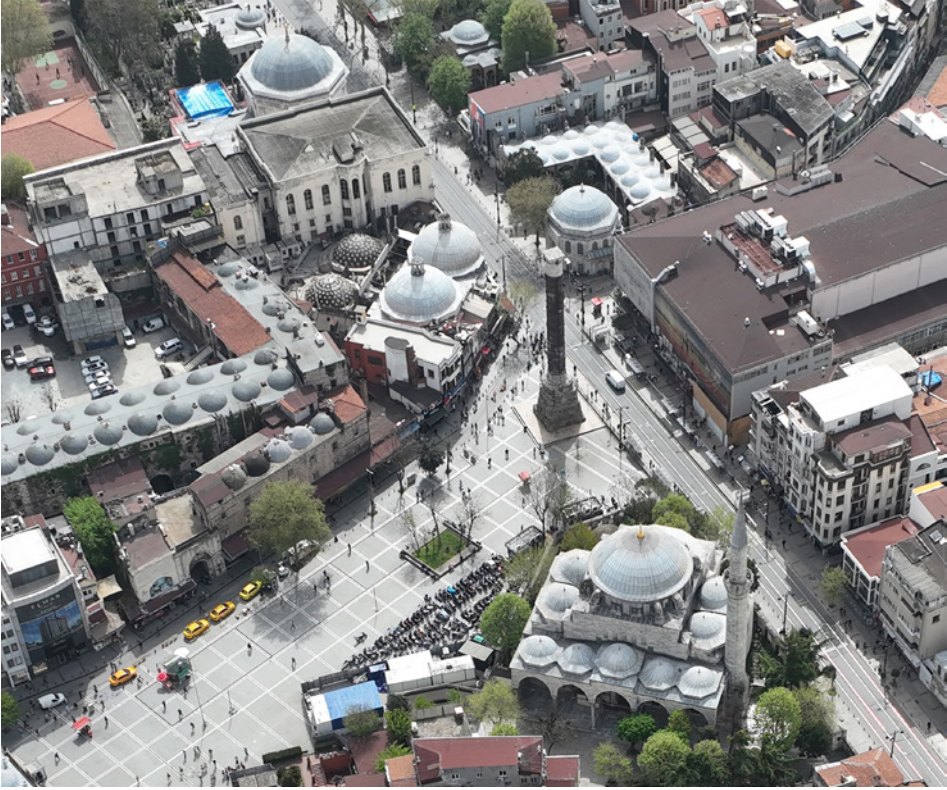
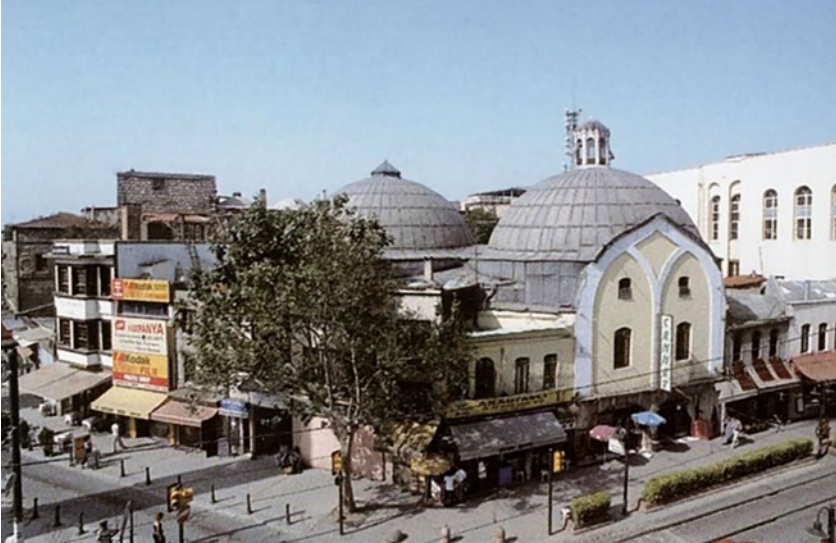
Due to its location, the bath has suffered damage from earthquakes and fires throughout its history. During the widening of Divanyolu Street in 1868, part of the women's *soyunmalık* was demolished<sup>78</sup>. According to Heinrich Glück's survey conducted between 1916 and 1917, the women's section was still in use, whereas the men's section was in a state of ruin<sup>79</sup>. During World War I, both sections were combined and temporarily repurposed as a military disinfection center, during which the original heating systems were altered or modified<sup>80</sup>. The building later came into private ownership, and the women's *soğukluk* was temporarily used for commercial purposes<sup>81</sup>. The men's bath parts were restored between 1972 and 1973, while the women's *soyunmalık* remained in commercial use and other rooms served as storage spaces. In 1988, the women's bath parts were reopened for bathing purposes<sup>82</sup>, and today, the bath continues to operate with its original function, primarily serving tourists.

Fig. 7. (a) The bath, located within the former Forum of Constantine I and surrounded by historical buildings (Photo: Authors, 2024); (b) the cut facade of the bath facing Divanyolu Street (Halil Onur Mimarlık İnş. San. Ltd. Şti., 1992)

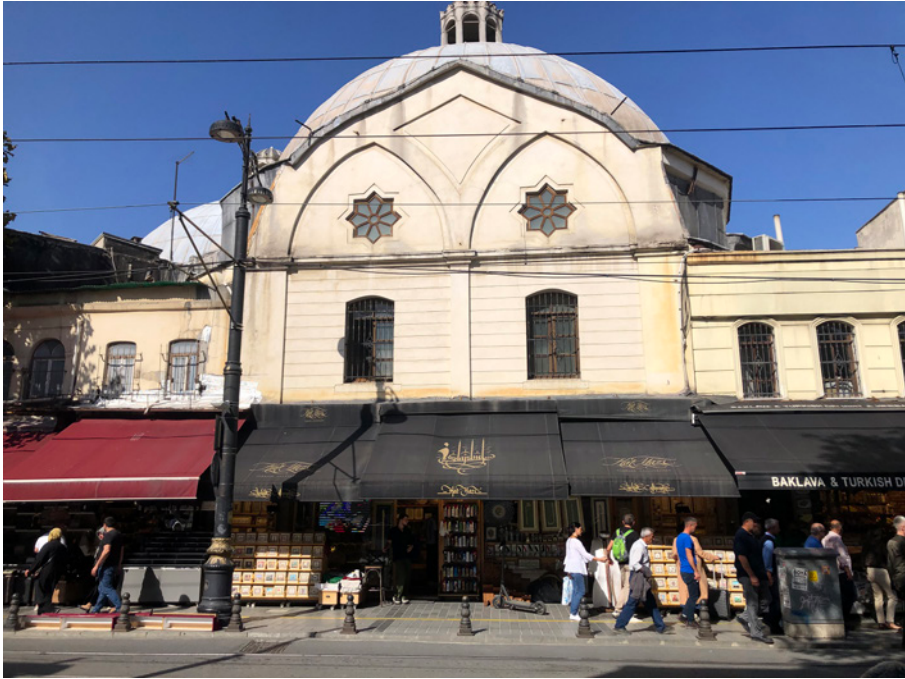
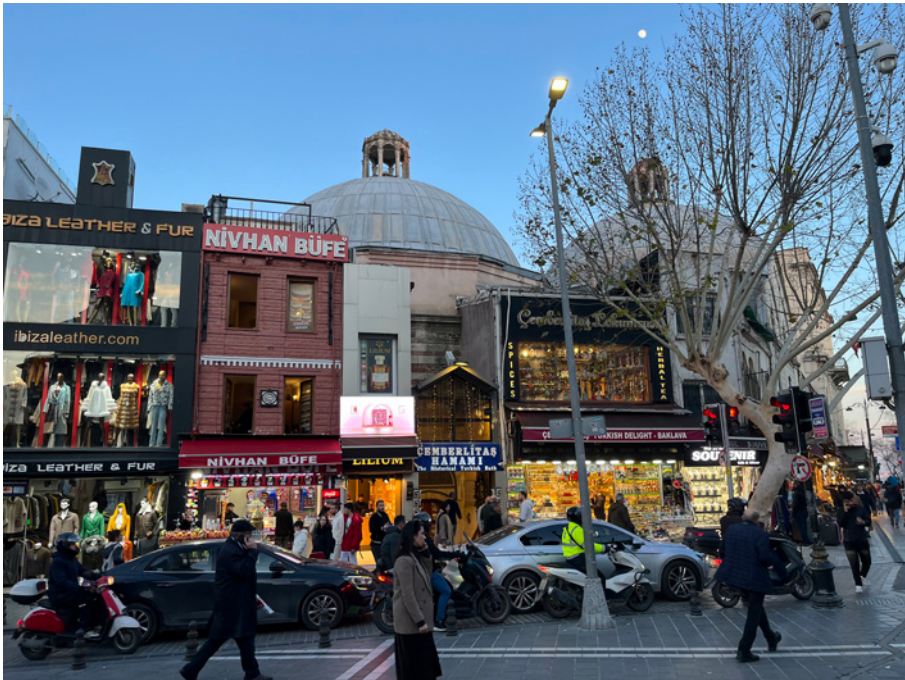
Today, the Çemberlitaş Bath continues to operate as a bathing facility, primarily serving tourists while also accommodating local users. The structure is surrounded by dense commercial development. A portion of the *soyunmalık* section facing Divanyolu Street was demolished during road-widening works, resulting in the loss of its original façade. The addition of low-quality retail units, signage, air-conditioning devices, and external cabling at street level has produced significant visual clutter. Vibrations caused by nearby traffic and tram lines further exacerbate the building's structural deterioration (Fig. 8a).

The entrance façade facing Çemberlitaş Square – named after the Column of Constantine, which stands at the center of the ancient Forum of Constantine – is similarly obscured by later shop additions, diminishing the architectural legibility and visual perception of the monument (Fig. 8b). The men's *soyunmalık*, accessed via stairs descending below street level, now functions as a shared reception, lounge, and souvenir area for both male and female visitors. Within the cold, warm, and hot sections, prolonged exposure to humidity, temperature fluctuations, insufficient ventilation, and long-term neglect have caused discoloration, staining, and cracking of marble surfaces; deformation and decay of wooden elements, and condensation and flaking of plaster finishes (Figs. 9a-9c).

Fig. 8. (a) The bath's façade facing Divanyolu Street; (b) the main entrance facade (Photos: Authors, 2025)

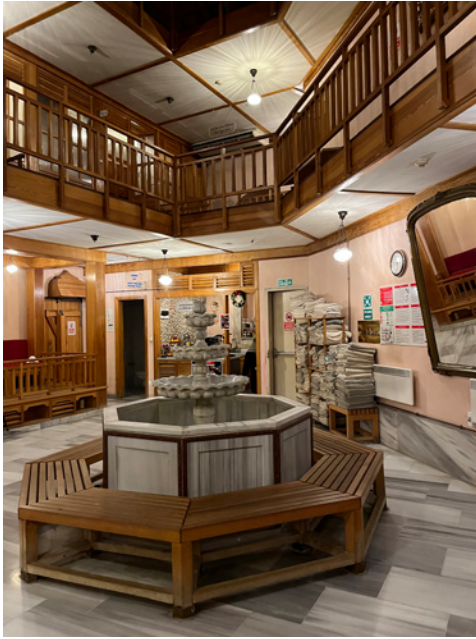
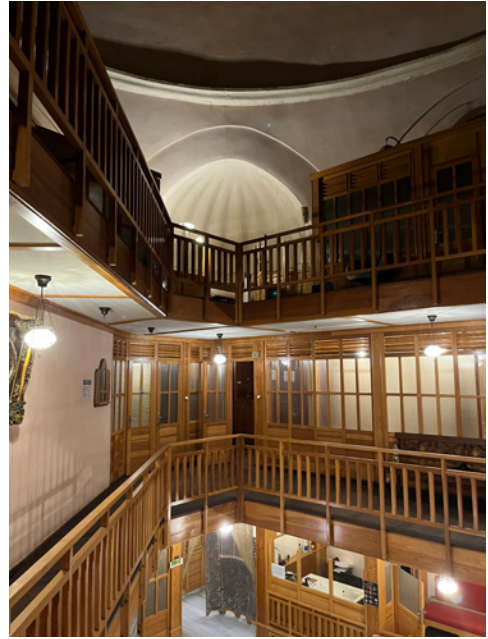
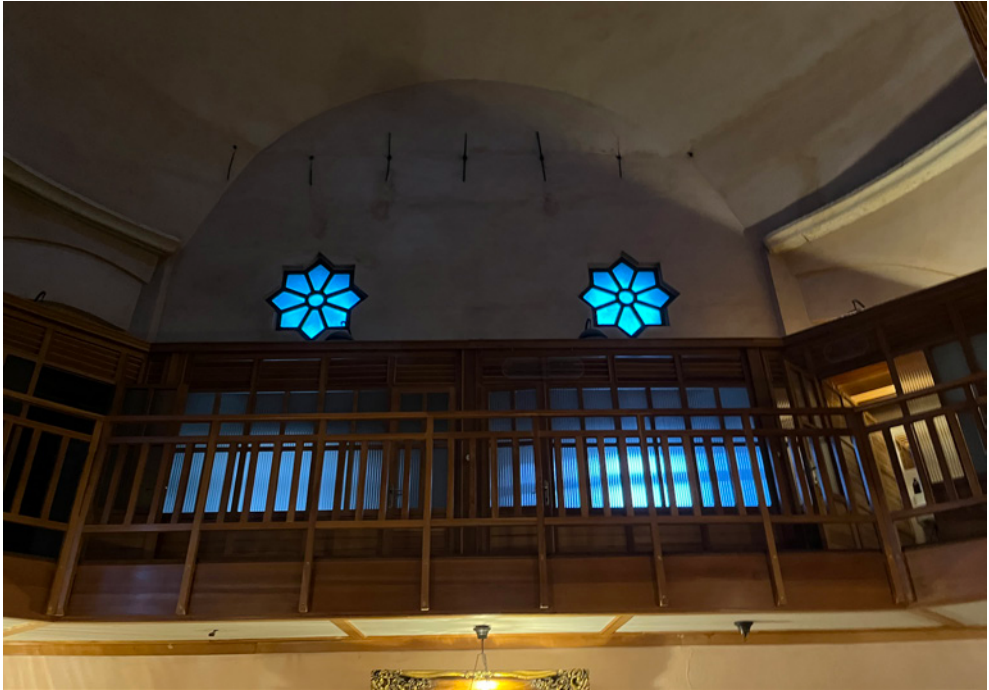
Fig. 9. (a) Women's *soğukluk* with stained and deteriorated marble fountain; (b) wooden changing rooms; (c) plaster deterioration above the upper-floor star windows on the cut wall (Photos: Authors, 2025)
