Assessing Carbonation Maturity for Restoration Compatibility: A Spectroscopic–Mineralogical Study of Historic and Modern Lime Mortars

Keywords: lime mortar; carbonation; material compatibility; historic masonry; ATR-FTIR; XRD

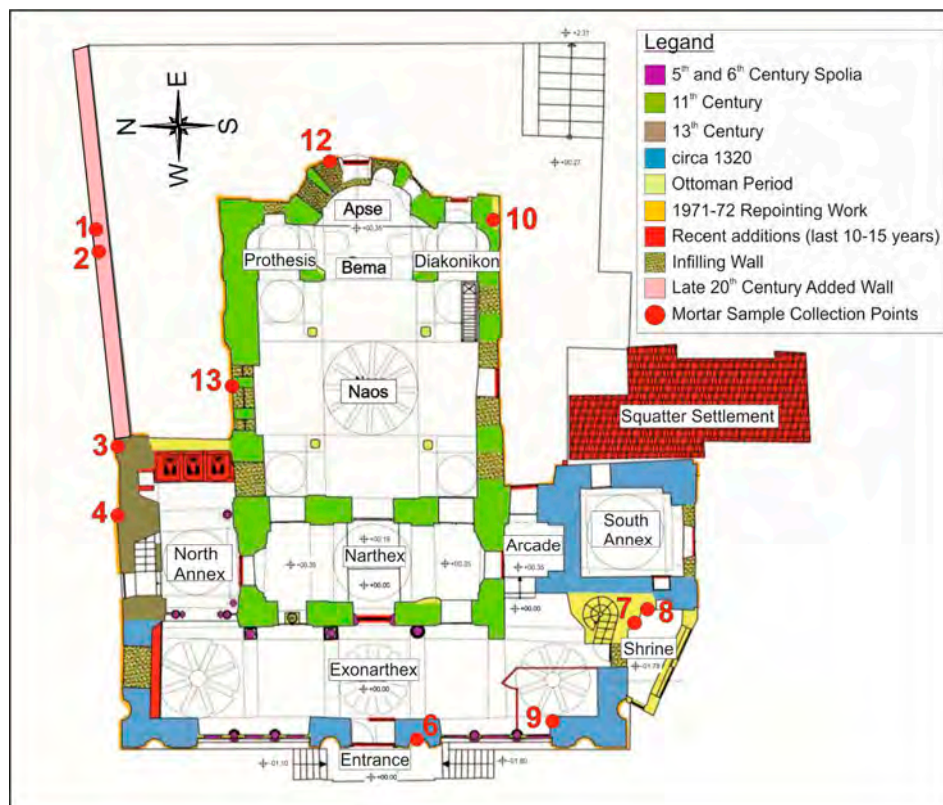
Figure 2. Architectural plan of Vefa Kilise Mosque and the chronological representation of its structural elements (modified from [20]). The analyzed laying mortars are marked with red dots, and sample numbers are indicated.

Additionally, two-layer mortar samples were collected from a wall added to the northern section of the structure during the second half of the 20th century. The carbonation levels of these samples were compared with those of the original historic mortars to evaluate potential compositional and chemical differences. The samples were analyzed as bulk powders, including both binder and aggregates. Through these analyses, the study aimed to provide a detailed assessment of the mineralogical and chemical composition of the

In contrast, the MG-1 and MG-2 samples, taken from the modern extension wall added in the second half of the 20th century (marked by a pink square in Figure 2), exhibited a broader C–O band at around 1400 cm^{-1} (highlighted with a red dashed circle in Figure 5c). This broadening suggests that the carbonation process in these samples is incomplete or proceeding in a less uniform manner. Several factors could contribute to this difference. While historic mortars are typically composed of pure lime ($\text{Ca}(\text{OH})_2$) as the binding material, modern extension walls may have used lime mortars with cement additives, which could influence the spectral properties. In cement-containing binders, the C–O absorption band tends to appear broader due to the complex nature of carbonation and the presence of additional mineral phases. However, no cement-related mineral phases or indicators were identified in any of the analyzed samples, suggesting that the MG-1 and MG-2 mortars are lime-based but at an earlier stage of carbonation.

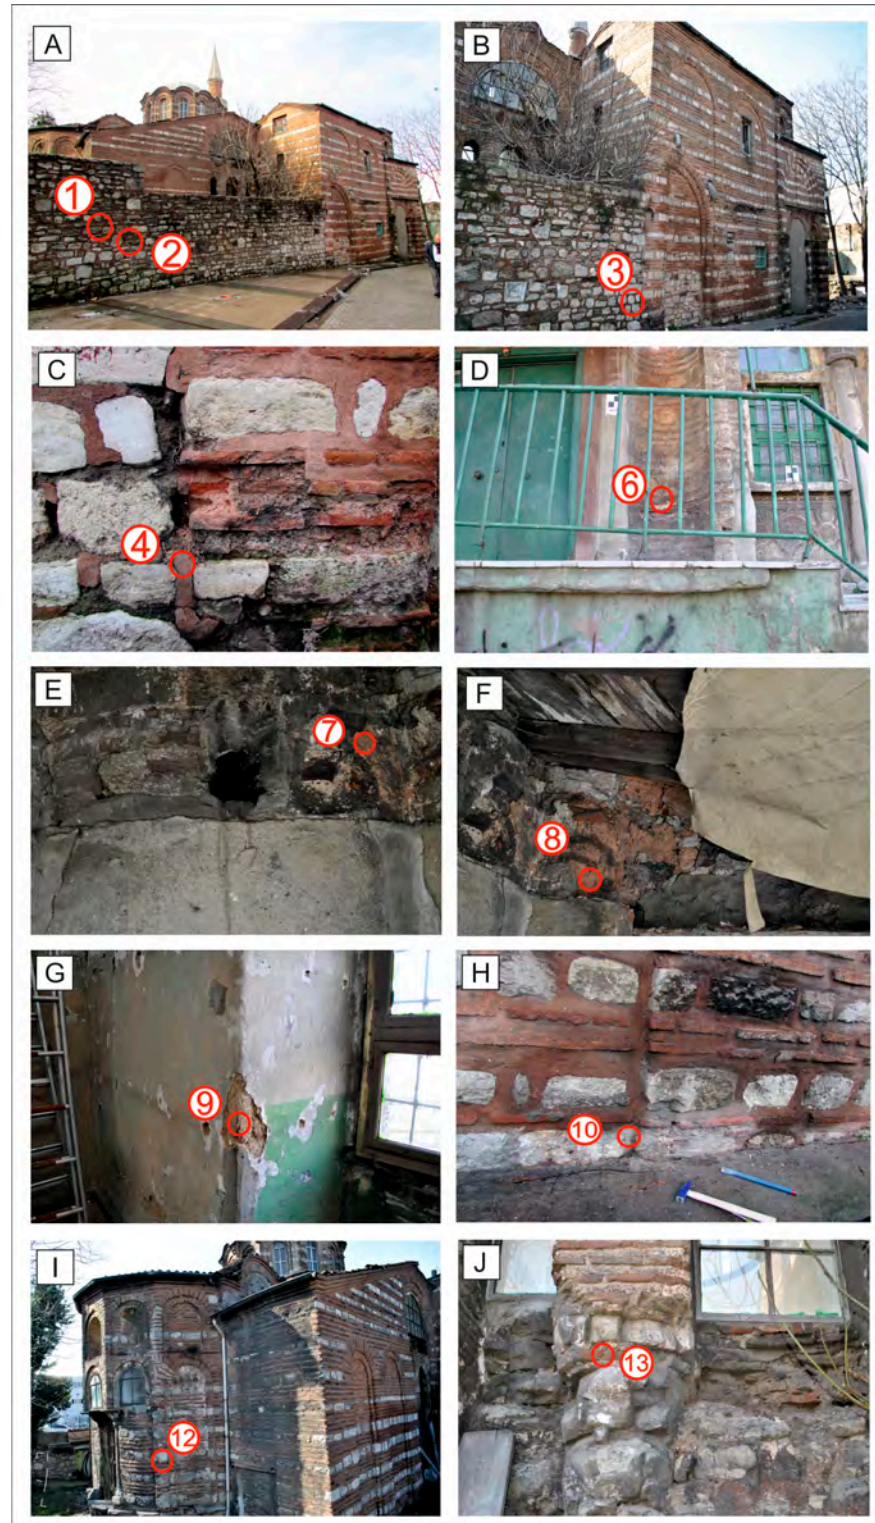
Figure 3. Sampling locations of the mortar samples. (A) Outer face of the northern garden wall (MG-1 and MG-2). (B) Lower level of the corner wall of the northern annex (MG-3). (C) Lower level of the semi-arched niche on the northern annex façade (MG-4). (D) Lower level of the niche to the right of the main entrance door on the entrance façade (MG-6). (E) Upper level of the oval minaret base inside the tomb structure on the southern façade (MG-7). (F) Upper level of the wall to the right of the minaret base on the southern façade (MG-8). (G) Interior wall surface of the entrance portico on the west side (MG-9). (H) Lower level of the exterior façade at the southeastern corner (MG-10). (I) Exterior face of the qibla wall (eastern façade, apse) (MG-12). (J) Between the brick and stone elements on the northern exterior façade (MG-13).

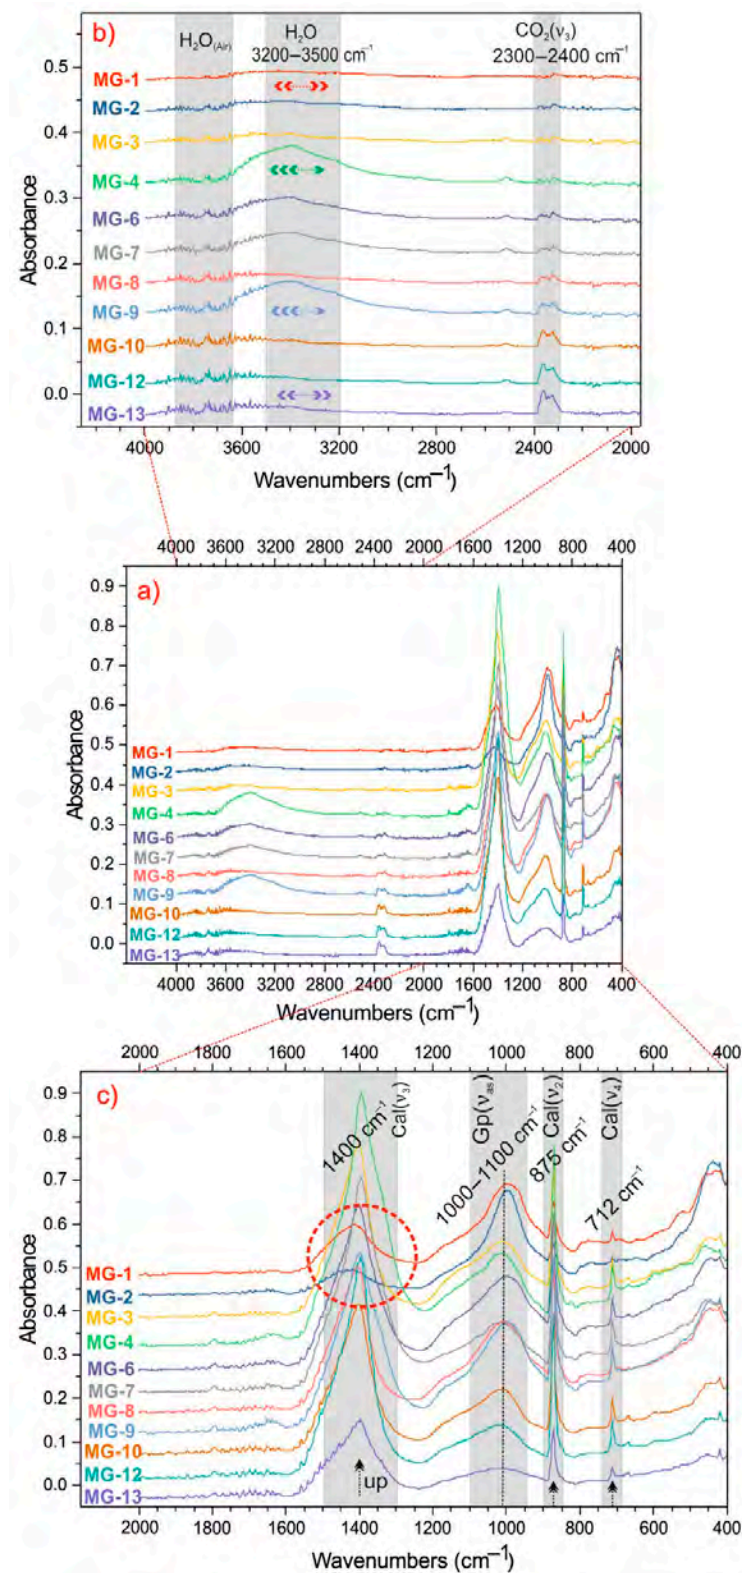
Figure 5. FTIR spectra collected from mortar samples. (a) Spectra obtained in the 400–4000 cm^{-1} range. (b) Detailed view of the absorption bands in the 2000–4000 cm^{-1} range. (c) Detailed view of the dominant absorption bands in the 400–2000 cm^{-1} range. (In (b), the broadening in the H_2O band is indicated by arrows in the color corresponding to each spectrum. In (c), the shapes of the characteristic peaks attributed to calcite are marked with black arrows as indicators of carbonation degree. Additionally, the incomplete carbonation process of the main calcite peaks in MG-1 and MG-2 samples is highlighted with a red dashed circle in (c)).

ATR-FTIR analysis of the historic masonry mortar identified dominant absorption bands corresponding to calcite (CaCO_3), gypsum ($\text{CaSO}_4 \cdot 2\text{H}_2\text{O}$), and silicate groups (Figure 5). The presence of calcite was confirmed by the characteristic C–O stretching vibration bands of carbonate compounds, observed in the $1400\text{--}1460 \text{ cm}^{-1}$ range (asymmetric stretching, ν_3), at 875 cm^{-1} (out-of-plane bending, ν_2), and at 712 cm^{-1} (in-plane bending, ν_4) (Figure 5c). The presence of gypsum was determined by the characteristic S–O stretching bands of sulfate groups, detected in the $1000\text{--}1100 \text{ cm}^{-1}$ region (asymmetric stretching, ν_3) (Figure 5c). Silicate groups, particularly those associated with feldspar and quartz minerals, were identified by broad Si–O–Si stretching vibration bands, observed in the $900\text{--}1100 \text{ cm}^{-1}$ range (Si–O stretching, ν_3) and the $450\text{--}500 \text{ cm}^{-1}$ range (Si–O bending, ν_4) (Figure 5c). Additionally, low-intensity carbon dioxide (CO_2) absorption bands were detected in the $2300\text{--}2400 \text{ cm}^{-1}$ range. Furthermore, broad O–H stretching bands associated with water molecules were observed in the $3200\text{--}3500 \text{ cm}^{-1}$ region (O–H stretching, ν_3) (Figure 5b). These findings confirm that the ATR-FTIR analysis supports the XRD results and verifies the mineralogical composition of the historic mortar. The distinct spectral features of calcite, gypsum, and silicate components provided valuable insights into the raw materials and binding properties of the mortar.

The observation of sharp and well-defined absorption bands at 712 cm^{-1} , 875 cm^{-1} , and around 1400 cm^{-1} in the FTIR spectra indicated an advanced level of carbonation in the historic laying mortars (marked by red and black arrows in Figure 5c). These bands are characteristic of calcite, with the $1400\text{--}1460\text{ cm}^{-1}$ region corresponding to the asymmetric C–O stretching vibration (ν_3), the 875 cm^{-1} band representing out-of-plane bending (ν_2), and the 712 cm^{-1} band associated with in-plane bending (ν_4). The sharp and distinct nature of these bands suggests that the carbonation process has been fully completed over an extended period, resulting in a highly stable mortar matrix. The presence of such well-defined calcite bands confirms that the mortar contains a fully carbonated lime binder, which is an expected characteristic of historic mortars that have been exposed to atmospheric conditions for a long time and gradually stabilized. The qualitative nature of spectral comparison was favored due to the low number of modern samples. However, future studies involving larger datasets will enable robust statistical modeling.

A further significant observation in the FTIR spectra was the behavior of the O–H stretching bands (3200–3500 cm⁻¹). In most samples, these bands appeared broad and weak (indicated by green and blue arrows in Figure 5b) or were nearly absent (marked by red and purple arrows in Figure 5b). This suggests that the mortar has undergone extensive drying and has a low moisture content. Fully carbonated mortars typically lose most of their bound water over time, which is consistent with these findings. Additionally, a low clay content could further reduce the moisture retention capacity of the mortar. Prolonged exposure to environmental conditions may have resulted in the evaporation of water molecules within the binder matrix, leading to the observed spectral characteristics. However, if a high clay content were present in the samples, more distinct O–H absorption bands would be expected. The fact that strong water-related bands were not observed suggests that the historic mortars have experienced a gradual reduction in water retention capacity, becoming mechanically drier and more structurally stable over time. While further compositional analyses such as TGA or SEM-EDX would clarify binder differences, the current study focused on spectroscopic features, which nonetheless revealed clear transformation gradients. Although pH measurements were not performed in this study, future research is encouraged to correlate spectroscopic findings with pH variations across different time-dependent exposure zones.
