# Examination of the severe impact of the February 6, 2023 earthquakes on Antakya district considering pulse-like ground motions, supershear rupture, and basin effects

Emre Gani <sup>a,\*</sup>, Sezer Öztürk <sup>b</sup>, Ali Sarı <sup>a</sup>

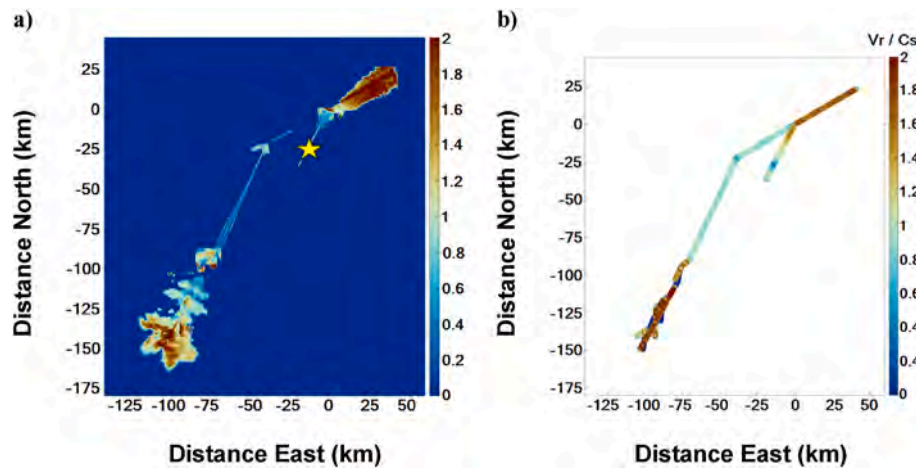
Fig. 3. a) The spatial distribution of the FP to FN velocity jump ratios computed from the numerical model, b) 2D plot showing rupture speed variation within the dynamic rupture model [24].

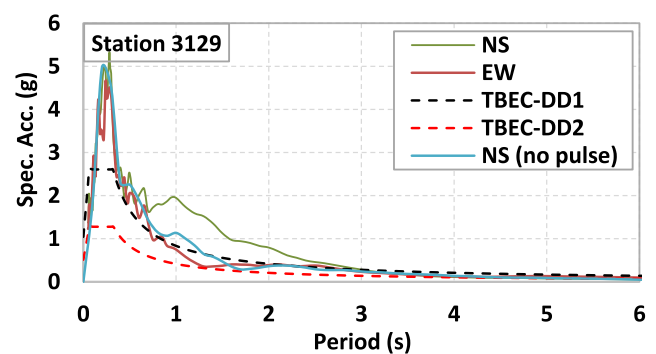
Fig. 7. Comparison of original and pulse extracted 3129 spectra with TBEC-2018 design spectra.

The horizontal component acceleration spectra of station 3129 and the horizontal elastic design spectra recommended by TBEC 2018 [31] for the station location are presented in Fig. 7. In the EW component spectrum, the DD2 level design accelerations were exceeded at all periods. DD1 level design accelerations were exceeded by a considerable amount up to the TB corner period (Region-1), but the exceedance from the TB threshold to periods of approximately 0.9 s remained relatively low. For periods above 0.9 s, the EW component accelerations and DD1 design accelerations were generally in agreement. The spectral accelerations of the NS component showed similar characteristics to the EW component and reached quite high values until the TB period. The NS accelerations for periods longer than the TB period initially showed similar behavior to the EW component but exhibited a region where DD1 accelerations were significantly exceeded in the range from 0.7s to 2.8s (Region-2). After 2.8s, the accelerations were again in agreement with DD1 design accelerations, similar to the EW component. Two particularly notable issues arise from this analysis: (1) the very high accelerations (up to around 5g) in the plateau region of the design spectrum until the TB period, and (2) the regional high spectral accelerations of the NS component in the 0.7s–2.8s range (Fig. 7).

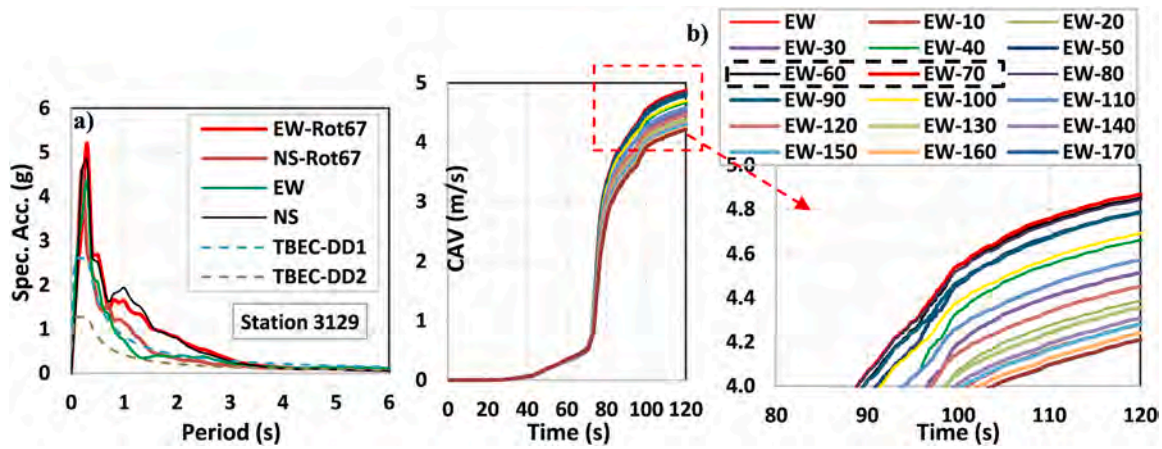
Fig. 9. a) The comparison of the pulse orientation (the NS direction of the original record) with the acceleration spectra in fault-parallel directions for Station 3129, b) CAV results.

For Station 3129, the comparison of the pulse orientation (the NS direction of the original record) with the acceleration spectra in fault-parallel directions is presented in Fig. 9a. The fault-parallel direction is derived by rotating the original record by  $67^\circ$ , thus corresponding to the EW acceleration spectrum. It is observed that the spectrum in the fault-parallel direction also exhibits high accelerations around 2 s, similar to the pulse orientation spectrum. This indicates that high accelerations persist even when transitioning from the pulse orientation to the fault-parallel direction, suggesting that the pulse effect is present across a broad range of orientations, including the fault-parallel direction. Considering that supershear effects are typically observed in the fault-parallel direction, this observation further supports the existence of supershear phenomena. This orientation-based inference is corroborated by the cumulative absolute velocity (CAV) results. In Fig. 9b, the EW graph represents the eastward direction (the EW component of the original record), corresponding to a  $0^\circ$  orientation. The highest CAV value is recorded at orientations of  $60^\circ$ – $70^\circ$ , which aligns with the fault-parallel direction. Therefore, it is plausible to discuss the magnitude of energy in the fault-parallel direction and its association with supershear phenomena.

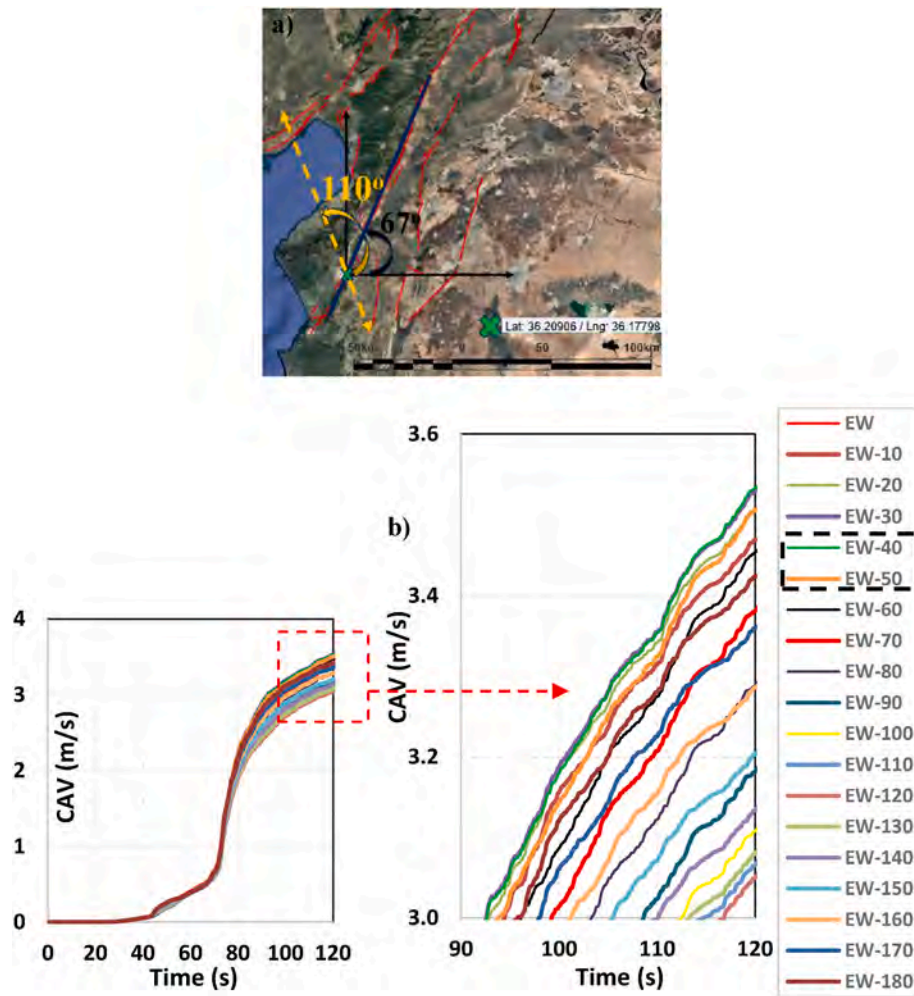
Fig. 13. a) Pulse orientation [61] and, b) CAV values at azimuth angles of 10° for station 3124.

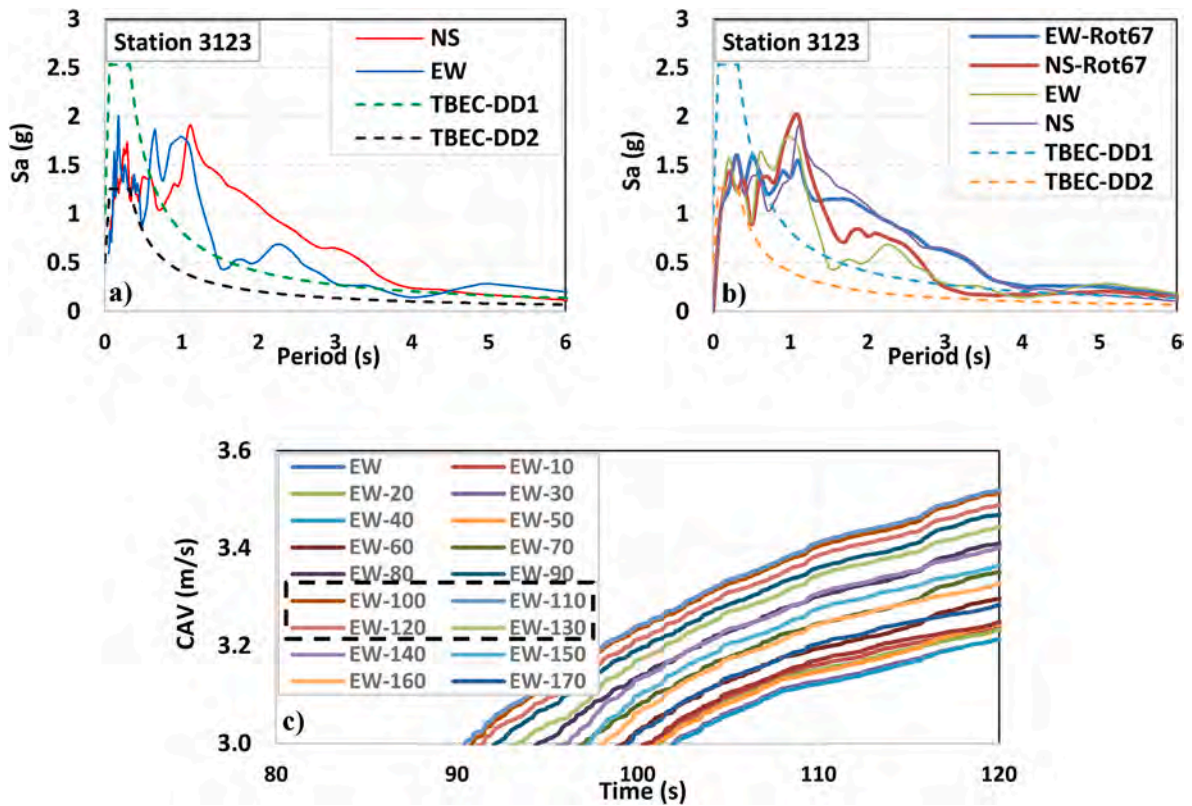
Fig. 15. a) Comparison of acceleration spectra, b) the rotated acceleration spectra and, c) CAV values for station 3123.

values are observed to range between 100 and 120° (Fig. 15c). These findings suggest that velocity pulses in the fault-parallel and fault-normal directions may coexist, with their resultant maximum energy appearing at an azimuth of approximately 110°.

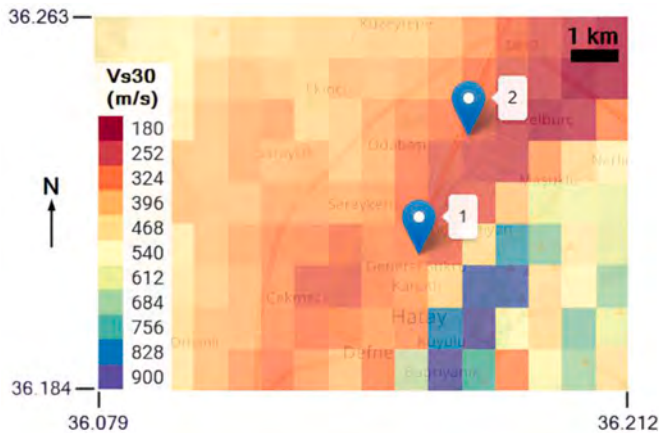
Fig. 16. Comparison of  $V_{s,30}$  values for stations 3123 (point-1) and 3124 (point-2) [79].

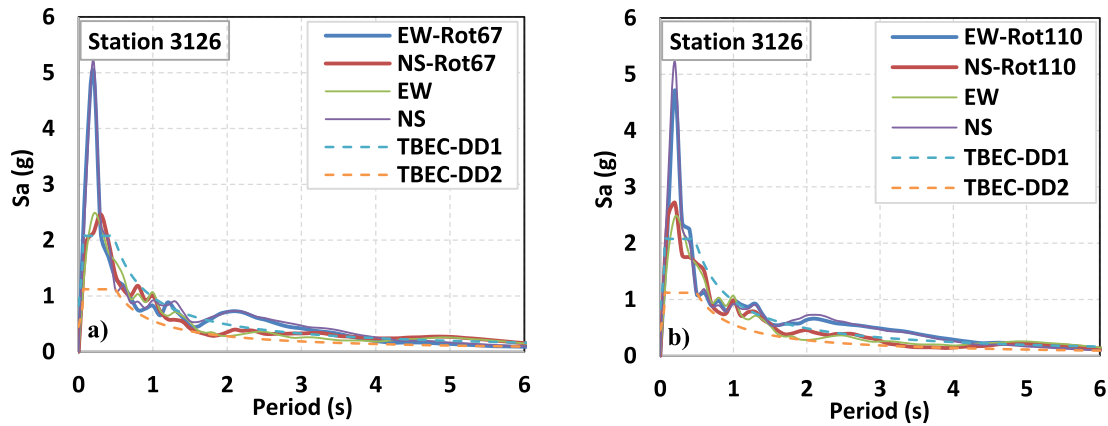
Fig. 19. Comparison of acceleration spectra by rotating the record as; a) 67° and b) 110°.

The spectral acceleration values for the EW and NS components of the 3126 station recordings exceed the TBEC 2018 [31] DD1 design accelerations, even for periods up to the 0.4-s threshold. In this region, particularly for the NS component, the accelerations are approximately twice those of the EW component. NS component accelerations reaching up to 4–5g suggest the potential influence of supershear effects. For periods longer than 0.4 s, the EW spectral accelerations are consistent with the DD1 spectrum, whereas in the NS component, DD1 acceleration exceedances are observed in the 1.7–4 s range (Fig. 19a).

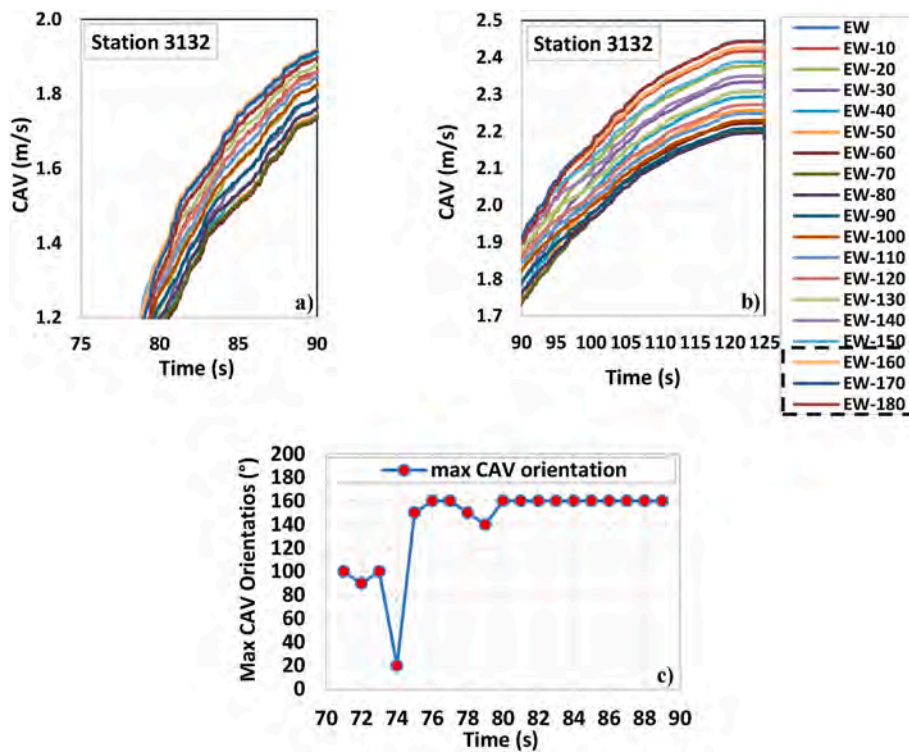
Fig. 23. a) CAV values for Station 3132, b) a closer view of the maximum CAV values, c) max CAV values corresponding to the 160° orientation.

CAV values for the entire earthquake duration were observed in the 160–170-degree orientations, which align with the fault-normal direction (Fig. 23a and b). During the initial seconds of the significant duration, a pulse-like seismic wave was generated in the 90–100-degree orientations, consistent with the rise in 1-s spectral accelerations in the original NS component. However, this effect did not exhibit a dominant pulse character comparable to those observed at other stations. Subsequently, due to wave propagation, energy was released in the fault-

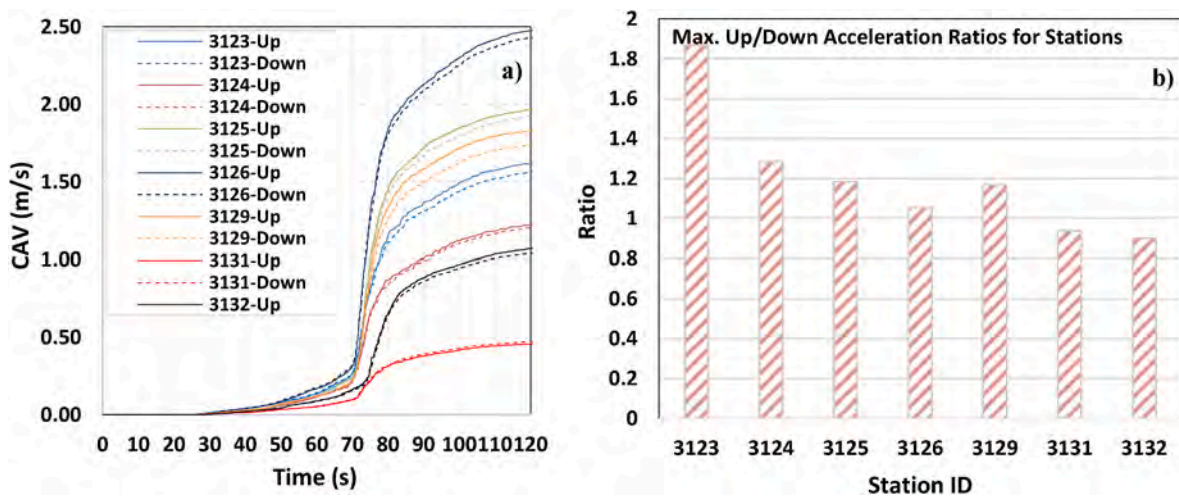
Fig. 27. a) Comparison of the CAV values of discrete positive and negative accelerations, b) maximum upward/downward acceleration ratios for each station.

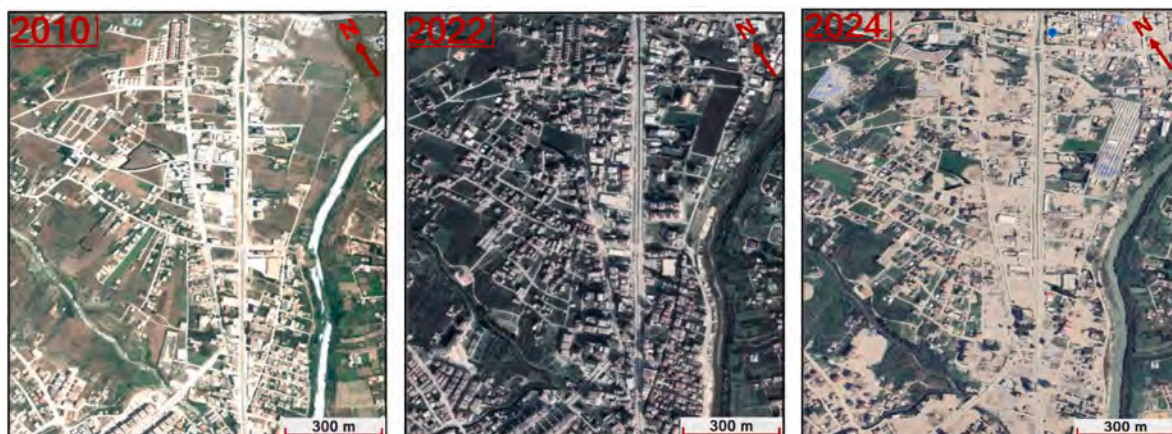
Fig. 28. Building stock in the Odabaşı region over different years [76].

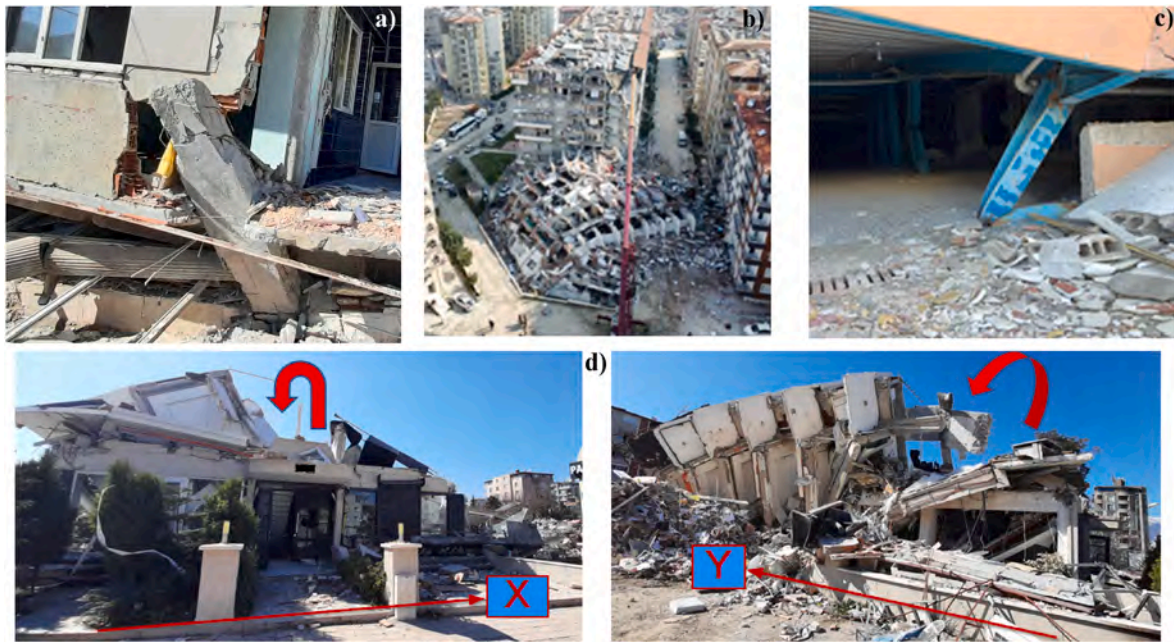
Fig. 30. Views of damaged/collapsed buildings illustrating the vertical seismic effects [13].

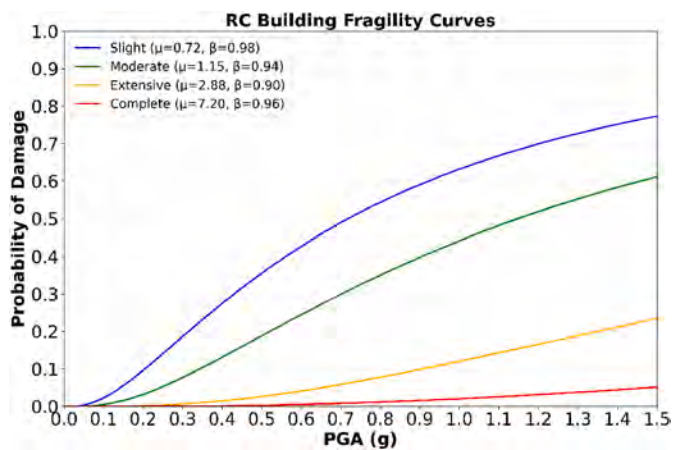
Fig. 31. Fragility curves provided by FEMA [85].

buildings were evaluated accordingly. Fig. 31 presents fragility curves for four different damage states: slight, moderate, extensive, and complete, as defined by FEMA. The lognormal distribution parameters for each damage state are shown in parentheses. The slight damage state represents very fine bending or shear cracks in some beams, columns, or joints. The complete damage state, on the other hand, is defined as brittle collapse or the loss of structural stability. The other damage states fall between these two extremes.
