# Panagiotissa through the layers of time: The Archive's memory of repairs and the present condition of the structure (1691-todate)

Beyza Hilal Altunışık<sup>a</sup>, Mine Esmer<sup>b,\*</sup><sup>a</sup> Restoration and Conservation Program, Fatih Sultan Mehmet Vakıf University, Istanbul 34015, Türkiye<sup>b</sup> Faculty of Art, Design and Architecture, Fatih Sultan Mehmet Vakıf University, Istanbul 34015, Türkiye

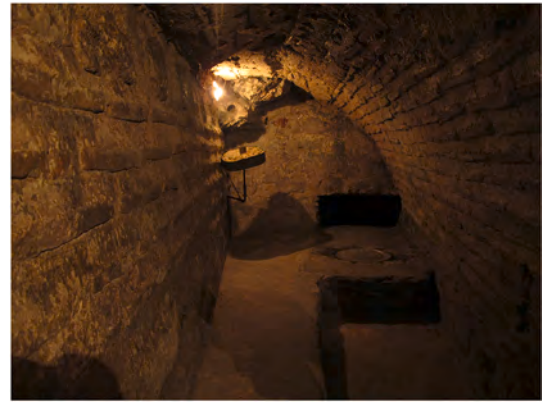
**3.2.1. Construction techniques and decorative elements**  
Despite the presence of thick plaster layers covering much of the structure, certain aspects of the original building fabric can still be identified. At present, the primary evidence of the original masonry is observable only on the north wall of the basement (Kimiseos tis Theotokou Hagiasma), located in the southwest part of the church (Bouras, 2005, p. 44) (Fig. 19). In this area, the characteristic Middle

Fig. 19 Muhliotissa, Kimiseos tis Theotokou hagiaσμα, recessed brick technique (Esmer, 2017).

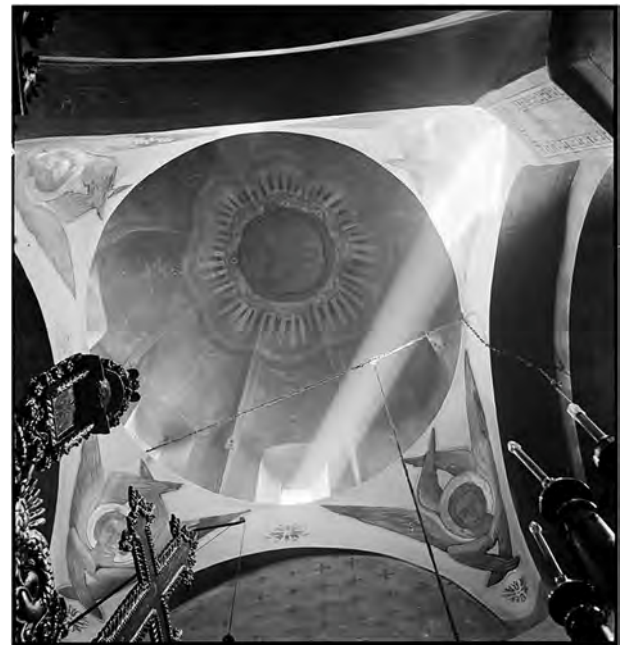
Wall paintings constitute another important, albeit heavily damaged, component of the building’s decorative heritage. Frescoes representing the Second Coming, discovered in 1899, have survived only in a severely deteriorated state and are believed to have been located on the eastern wall of the church’s extension (Bouras, 2005, p. 48). Furthermore, frescoes dating to the Ottoman period—also identified in 1899—were subsequently destroyed during repair works carried out prior to 1948 (Fig. 20) (Bouras, 2005, p. 48).

Fig. 20 Photograph of the main dome by N. Artamonov (Nicholas V. Artamonoff Collection, 1930–1947, Image Collections and Fieldwork Archives (ICFA), Dumbarton Oaks Research Library and Collection).

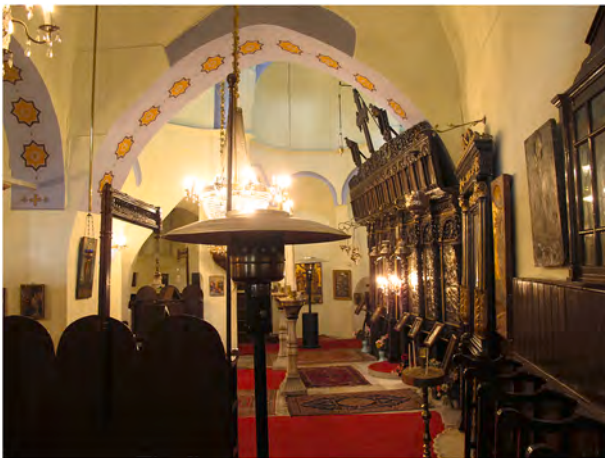
| Intervention type | Description |
|---|---|
| <b>Demolition and expansion</b> | The original niches to the south and west were demolished for the southern addition made around 1730. Only the lower part of the western niche was demolished (Fig. 21). |

**Fig. 21** Muhliotissa, view of the iconostasis from the north (Esmer, 2017).

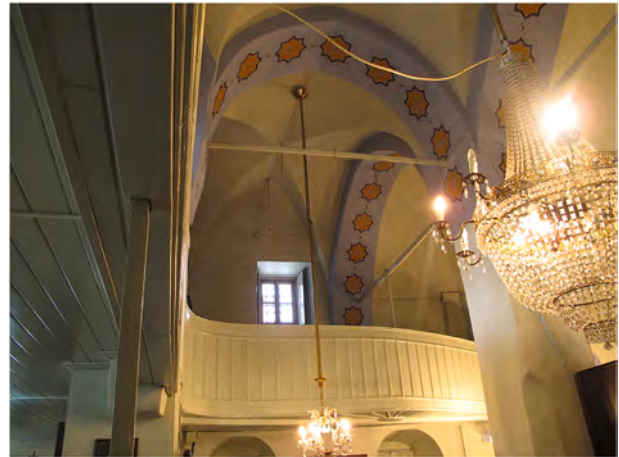
| Intervention type | Description |
|---|---|
| <b>Additions</b> | A trapezoidal-planned section with Ottoman-style pointed arches and cross vaults was added to the south. The southern part of this addition was turned into a women's gallery (gynaikonitis) with a wooden intermediate floor. A lower-level pentagonal exonarthex was built to the west (Figs. 22 and 23). |

**Fig. 22** Narthex with cross-vaulting (Esmer, 2017).

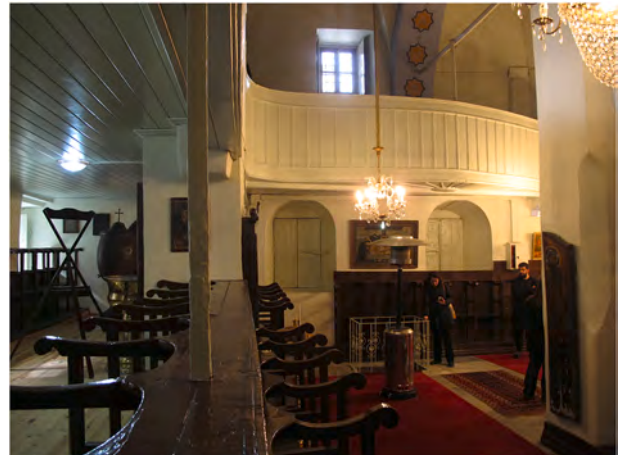
**Fig. 23** Muhliotissa, gynaikeion (women's gallery) (Esmer, 2017).

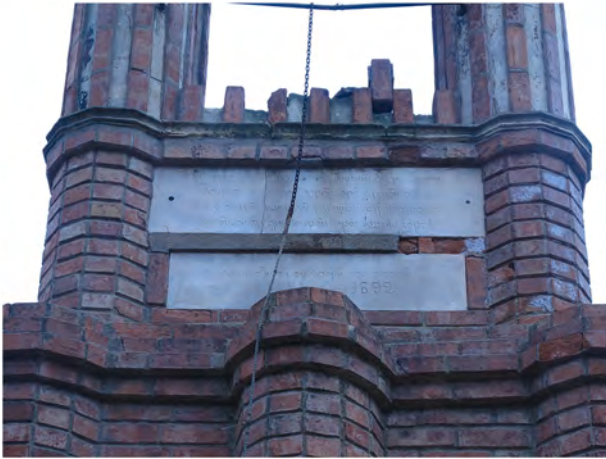
obstacles. A bilingual document dated June 3, 1892, written in Ottoman Turkish and Greek, shows that the Ministry of Justice and Sects ordered the suspension of construction on the church's bell tower. The justification was that the rebuilt tower exceeded its previously permitted height (Fig. 30). This intervention demonstrates that even repair-oriented building activities were subject to close state supervision and strict regulatory limits.

**Fig. 30** The date 1892 is visible on the inscription of the bell tower of Muhliotissa (Esmer, 2017).

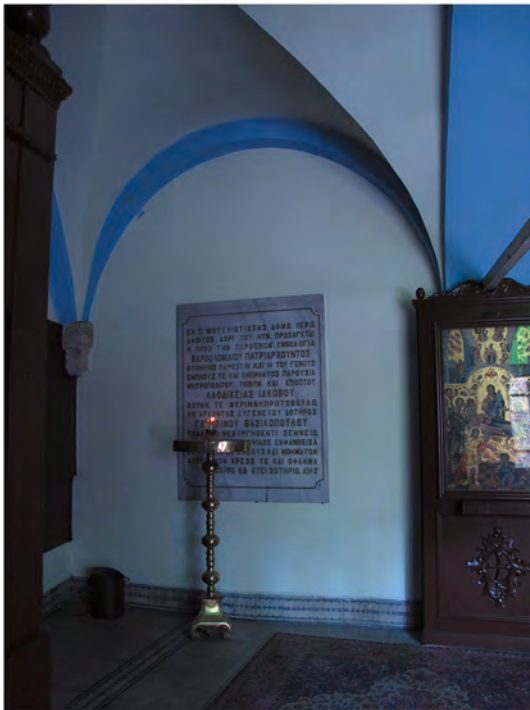
The most recent major restoration of the church is documented not in archival records, but through an inscription located within the building itself (Fig. 31). According to this inscription, the church was restored in 1997 during the time of Patriarch Bartholomew, with the support of the benefactor Gerasimos Vasilopoulos.<sup>2</sup> This final record completes the documentary narrative of the Panagiotissa Church and provides a basis for a comprehensive evaluation of all available data (Table 7).

**Fig. 31** Inscription belonging to the 1997 restoration of Muhliotissa (Esmer, 2017).
